# M.D. Mashtakov's House in the Context of Historical Wooden Samara

Urban wooden buildings of the 19th – early 20th century have a significant historical and cultural value. We have analyzed the typology of wooden buildings in Samara and conducted architectural/structural and stylistic analysis of the study objects. This article presents the results of the survey and restoration of a prominent cultural heritage site in Samara: the house of Mikhail Dementyevich Mashtakov. It describes the construction history of the house, outlines its restoration concept, provides justification of the restoration solution, and defines the criteria for restoration feasibility assessment.

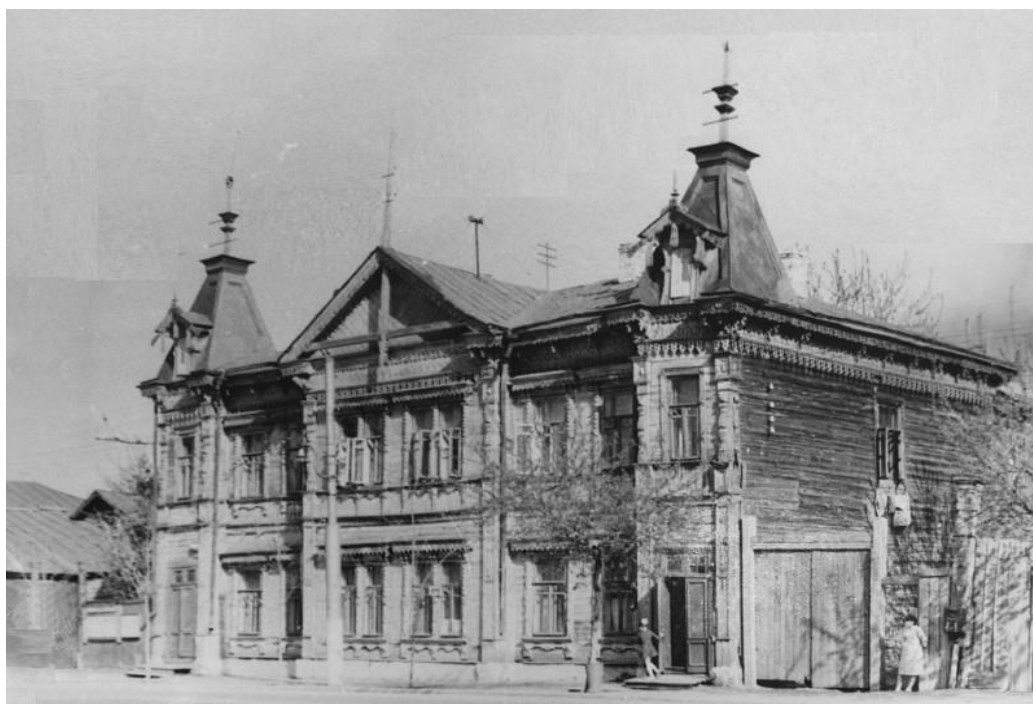
**Figure 1.** M.D. Mashtakov's house: street view.

One of the most remarkable and distinctive wooden buildings in Samara is the house of M.D. Mashtakov located at 207 Samarskaya Street (Fig. 1). It is a two-story wooden structure placed along the public property line of Samarskaya Street, with its corner facing the former Voskresenskaya Square. The building is rectangular with three avant-corps at the street facade. Structurally, it is divided into three main parts by two lateral bearing walls. The house is divided into small apartments. It has two entrances and two sets of stairs on corners of the street facade.

The main facade of the building is symmetrical. There is a wide avant-corps in the center crowned with a triangular gable, and two avant-corps on the corners with quadrangular tent-roofed turrets with small windows. The facade is decorated with pilasters, cornices, belt courses, and rich carvings. The inter-story cornice is a wide belt course formed by two profiled bars. Window openings have a complex decor. The top string of the cornice is at second-floor windowsill level. The window trims are carved columns on both sides of the windows ending with a cornice on carriers richly decorated with carvings. The bottom trim piece with a small apron and side overhangs is incorporated into the decor of the inter-story belt course. The façade is clad with battens oriented in different directions. All this creates an expressive, complex, and vivid image. The lateral facades and the backyard facade are very neat with little decor.

The house has a low-pitched hip roof with two quadrangular tent-roofed turrets above the avant-corps on the corners. Subroof structures include a set of close couples. Roofing is sheet iron; turrets are clad in a checkered pattern. The front facade of the turrets has a dormer window with elegantly carved trims. Downpipes are used to remove rainwater off the roof.

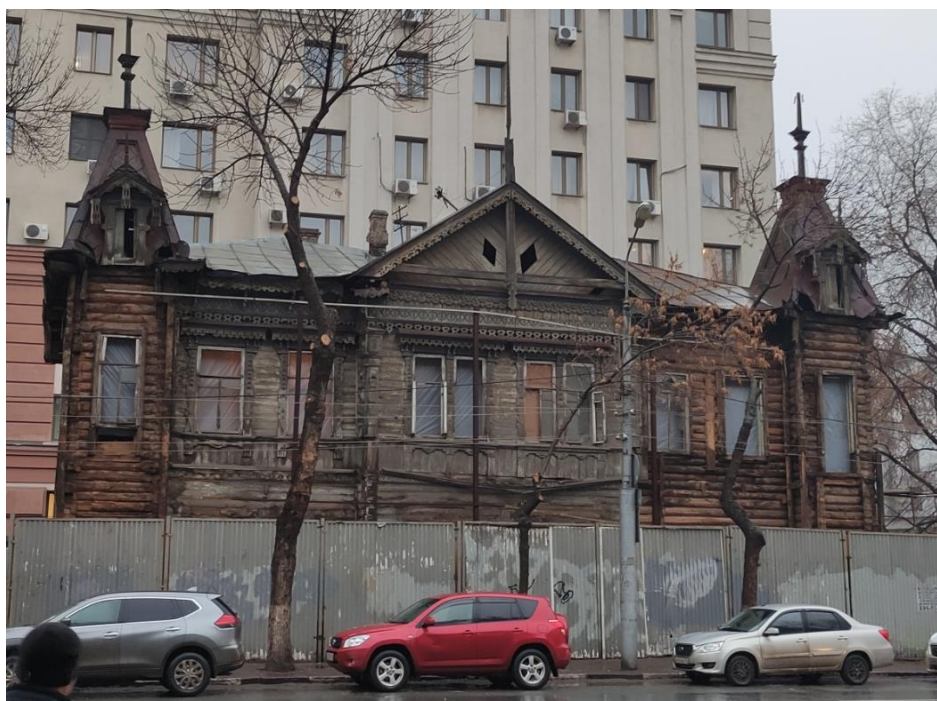
**Figure 3.** State of M.D. Mashtakov's house before restoration.

The building was initially constructed for the personal use of a rich owner, which is proved by its extraordinary architecture (Fig. 3). Now we see rather a modest apartment housing with small rooms.
